To Repair or Replace?

Renovating an Apartment Community with USPS Compliant Centralized Mailboxes

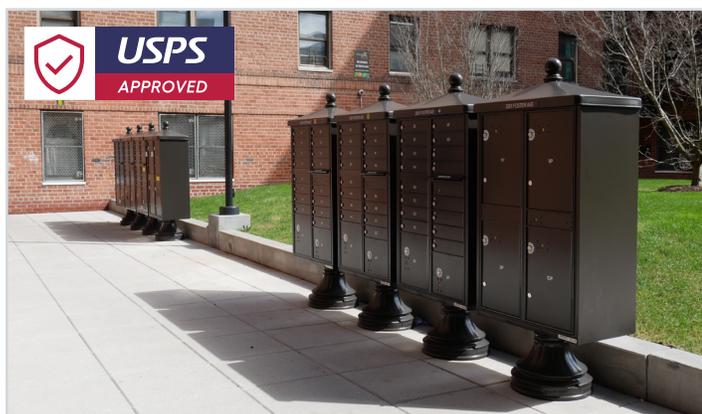
CLUSTER BOX UNITS

A cluster box unit (CBU) is a centralized mailbox that is **freestanding and pedestal-mounted**, designed for outdoor installation, individually or in large group installations.

- Choose from 6 standard configurations with up to 16 locked residential compartments and up to 4 integrated parcel lockers.
- Residential mail compartments and shared parcel lockers are numbered with a decal or engraved.
- Expand capacity for package deliveries by adding matching Outdoor Parcel Lockers (OPL).
- Pedestal included ensures mailboxes and parcel lockers comply with USPS installation regulations.
- Dress up the basic CBU & OPL with decorative accessories to complement your building.

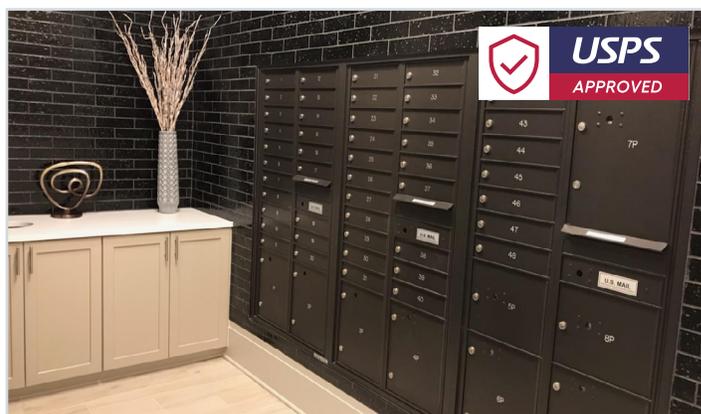
STD-4C MAILBOXES

USPS STD-4C mailboxes (4C) are similar in structure to CBU except they are **designed to be wall-mounted** indoors or outdoors, individually or in large group installations.

- When installing equipment indoors, only USPS STD-4C fully recessed wall-mounted units are permitted. Surface mount, free standing, or pedestal-mounted 4C installations are not USPS Approved.
- Choices are plentiful when using STD-4C mailboxes with dozens of pre-configured modules in varying heights.
- When installing 4C equipment, there must be one parcel locker for every five customer mail compartments. For those buildings with a minimum of five mail compartments, there must be at least one parcel locker installed.
